POLYDOROS LX 30/50

Troubleshooting Guide

Print No.: RX63-020.840.01.02.02
Replaces: RX63-020.840.01.01.02

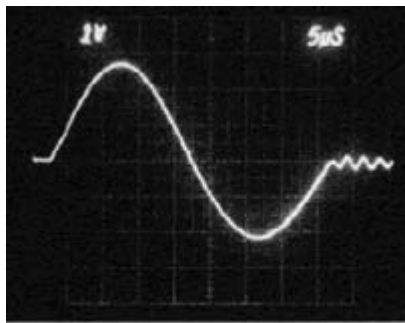
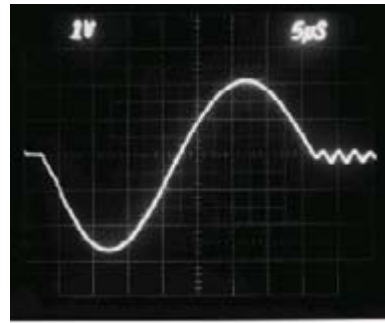
Fig. 1:

- The following requirements are to be checked in both oscillograms:
 - "Forward oscillation" : 270A \pm 10%
 - "Backward oscillation" : 210A \pm 10%

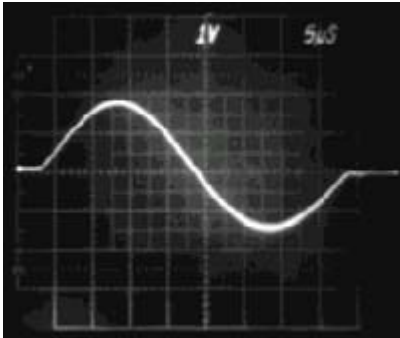
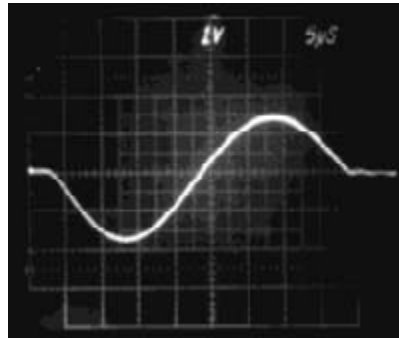
Fig. 2:

- The following requirements are to be checked in both oscillograms :
 - "Forward oscillation" : 180A \pm 10%
 - "Backward oscillation" : 140A \pm 10%
- On deviations in the amplitude:
- Generator OFF
- Connect oscilloscope to following points:
 - CH1: D100/X60 OUT_A
 - CH2: D100/X60 OUT_B
 - Trigger: D100/X64 SWR
- Switch on D100 OFF
- Generator ON
- Release FL or exposure.
- Compare pulses with diagram X2169-16, Replace D100 in the case of deviation
- If pulses are OK proceed as follows:
 - Replace inverter

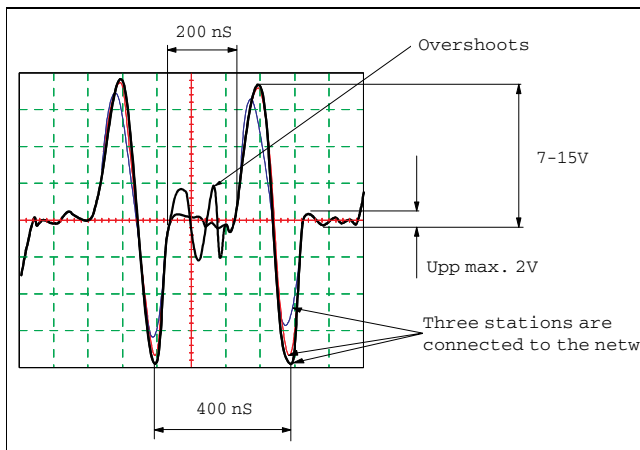
Fig. 5: Reflections in the XCS network

Shielded twisted pairs are used for data transfer (labeled as Phase A and Phase B in the Wiring Diagram). These cables have a defined impedance and attenuation. Because of this, the amplitude of the transmit signal is somewhat less from a station farther away from the test location. Since all stations send the token cyclically on the line, the adjacent oscillogram is obtained when a passing trigger point is set.

- Check the XCS plug-in connections; Is the shielding correctly clamped? Are cables pinched or damaged?

- Take one XCS component out of the XCS network and terminate it with a terminal resistor. Repeat the measurement of the XCS cable network; if an improvement is found, the XCS cable or the disconnected XCS component can be the cause.
- If disturbances cannot be corrected in the XCS cable network using Corrective Measure 1 or 2, replace the D200.
