SIEMENS

MOBILETT XP Digital

Troubleshooting Guide

Imaging System

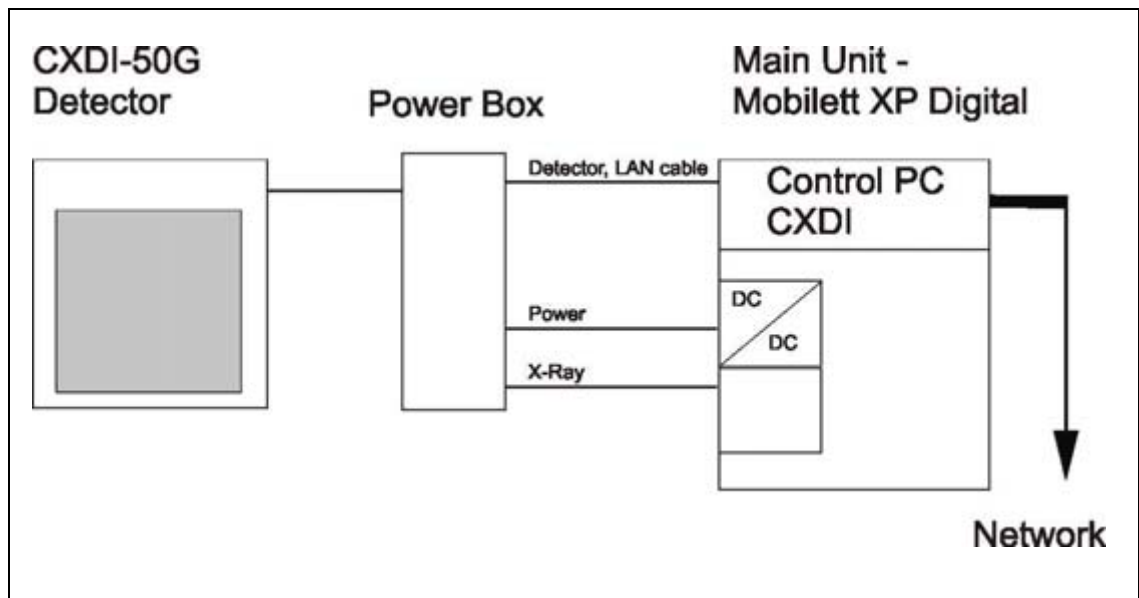
Fig. 1: Imaging system

The image system consist of the following components:

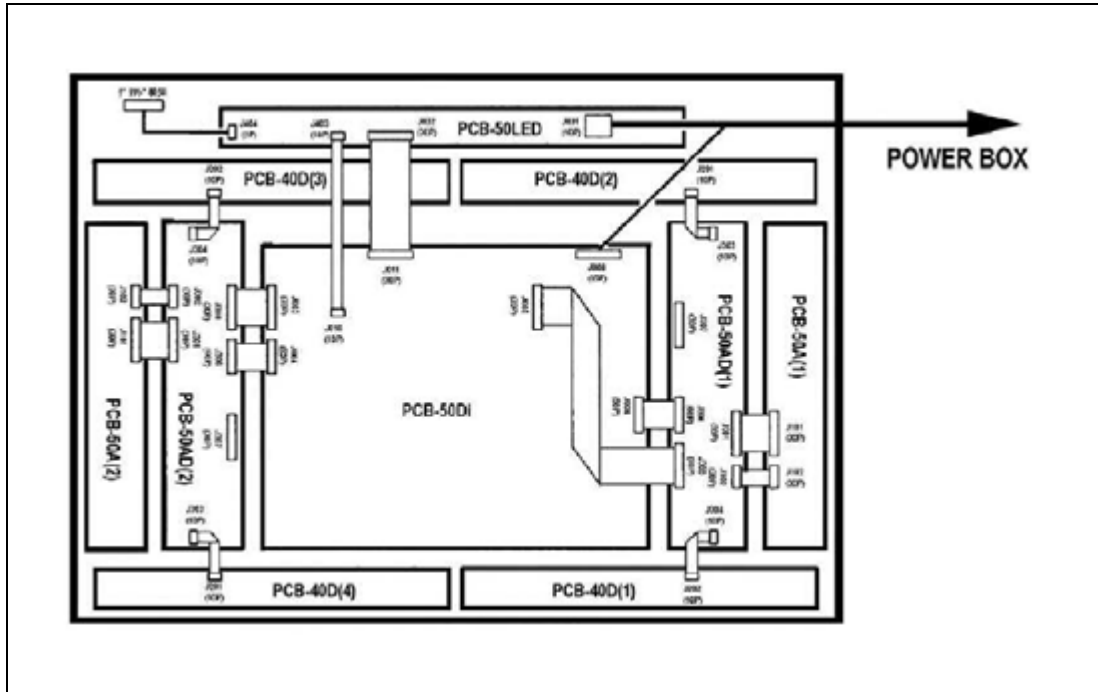
Fig. 2: PCB 50Di board of the detector

The PCB-50Di board has the following functions:

- The sensor driving control. Reading the digital image signals output from the AD converter (PCB-50AD)
- Communication, X-ray image transferring with the CXDI PC via the power box on the Ethernet.
- Synchronization of X-ray generation and image acquisition via the power box.
- Control of the LED display.
- Detection of the grid using the grid detecting sensor.
- Relaying of the power supplied by the power box to the PCB-50AD.
- Detection of an unusual temperature, error reporting and stopping of sensor driving.
- Detection of the X-ray emission status.
- Holding of the factory data set.

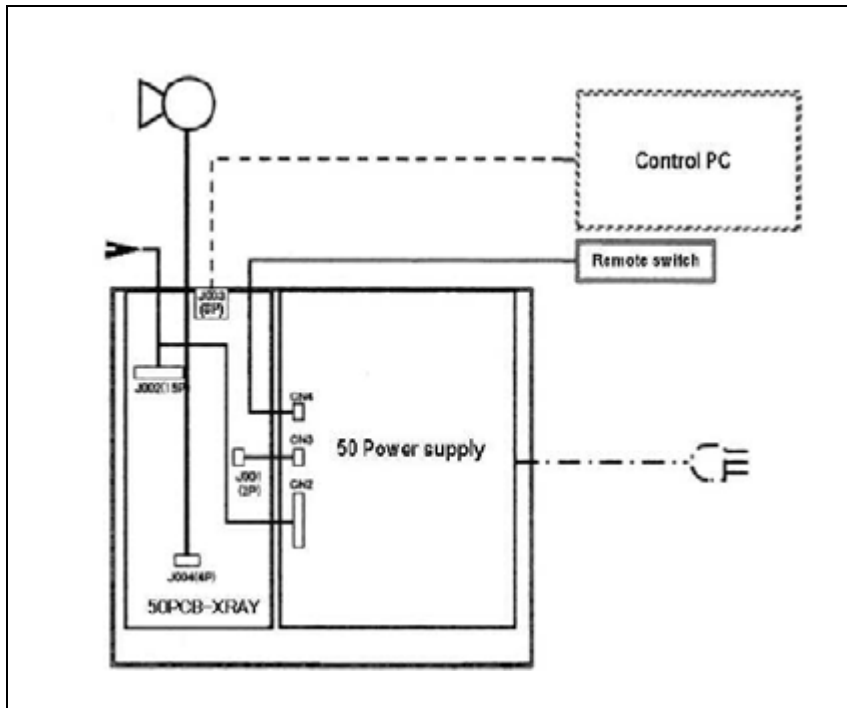
Fig. 3: Power box

The power box that connects to CXDI PC has basic insulation against the 230V AC and also has an electric separation device.

The power box consists of the following parts:

Function of the power box:

The power box controls signal transition with the detector (imaging unit), power supply, signal transition with the X-ray generator. The power box can be connected to only one detector (imaging unit).

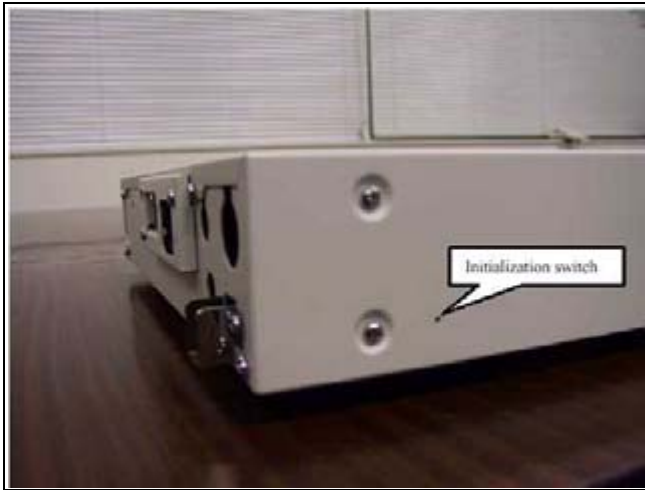
Fig. 6: Power box installation switch

In this case, the connection can be made by setting the Ethernet settings in the control PC to the 50G default (*2).

This default connection allows you to upgrade the firmware again and also to check and set the Ethernet settings again in order to recover the system.

Initialization switch: Switch 1 mounted on PCB-50 XRY

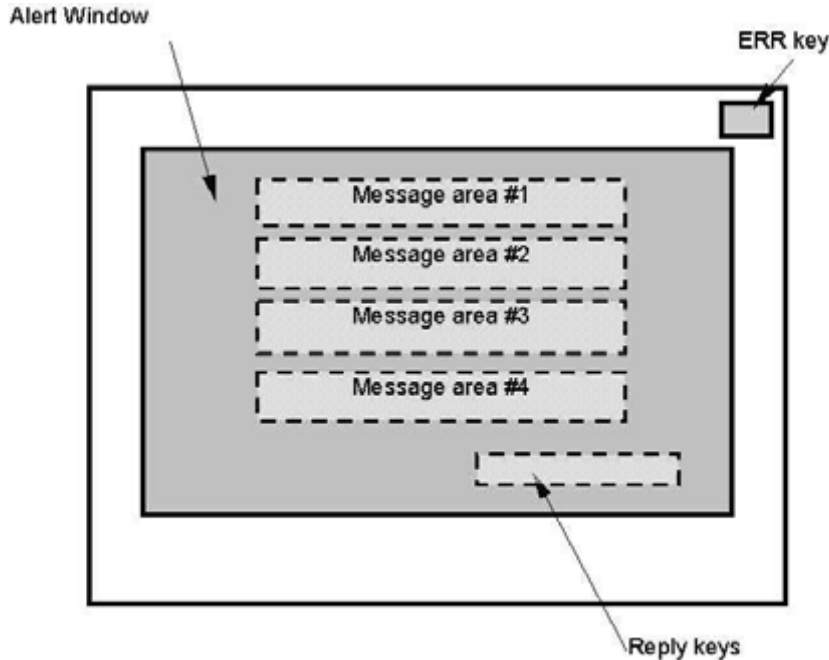
Fig. 7: Alert window

The following table shows the alert code window.

Area #	Severity	Auto-matic display	Blinking of "ERR"	Meaning
1	Fatal error	Yes	Yes	The whole screen blinks red and the alert window appears automatically. The system cannot be recovered. A service person must be called.
2	Alert	Yes	Yes	A red ERR key blinks and the alert window appears automatically. The exposure cannot be continued without a user operation.
3	Error	Yes	No	A red ERR key is displayed and the alert window appears automatically. The ERR key does not blink. The chances of the user being able to recover the system is better than for an alert.

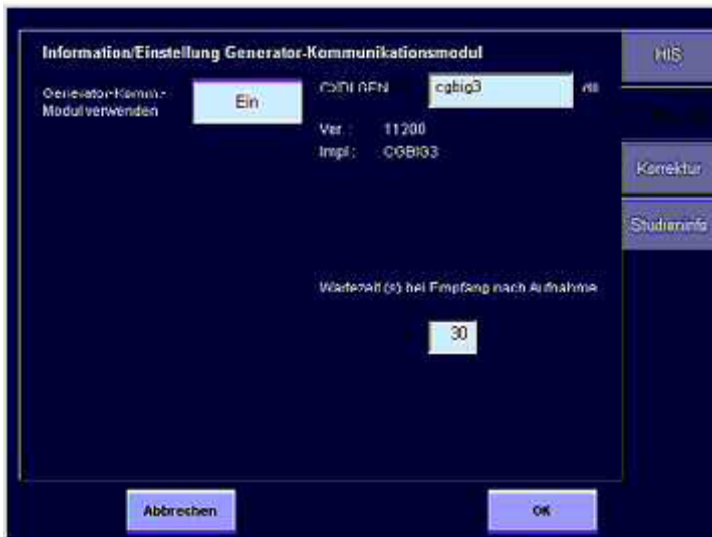
Fig. 8: Generator setup

Procedure for checking the generator module:

- Select SYSTEM/CONFIGURATION/ADMINISTRATOR SETUP/MODULE/GENERATOR.
- Enter the administrator password.
 - ⇒ See password list.
- Check CXDI GEN value: cgbig3 (Fig. 8 / p. 64).
- Check the generator communication module: valid (Fig. 8 / p. 64).
- Click "OK".

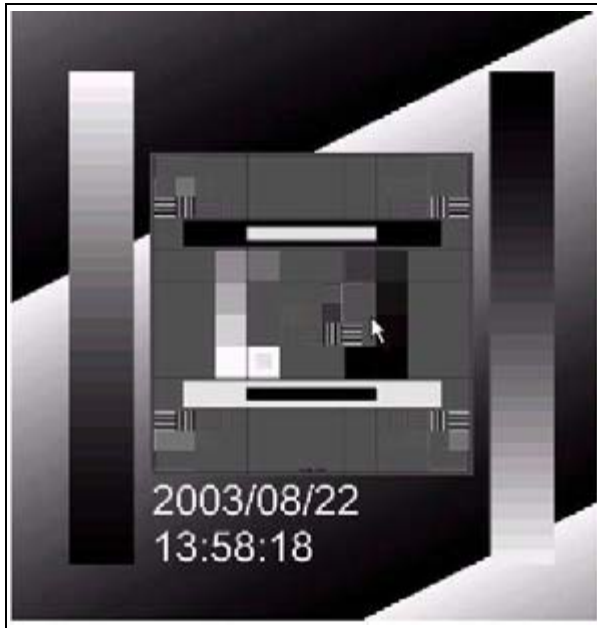
Fig. 9: Imaging system

Find the SMPTE image for test uses under the organ program “Test/ SMPTE”.

- The MOBILETT XP Digital is switched on.
- Create a patient “IQ Test” and call up the organ program “Test/ SMPTE”.
- Wait until “READY” appears on the display and press the exposure switch.
- Wait until the image is transferred to the display.
- On the exposure screen, select test, then the exposure mode “SMPTE” and wait until “READY” appears.

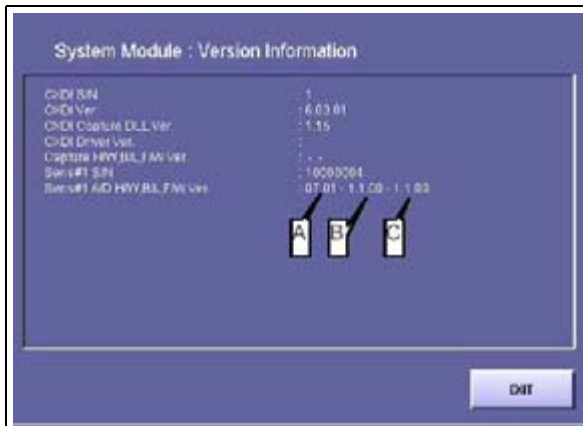
Fig. 10: CXDI firmware

- Start up the MOBILETT XP Digital.
- Select “SYSTEM > SETUP MENU > VERSION INFORMATION”

- A. Hardware version
This is the version of the detector hardware. It changes according to the setting of the dipswitch on the PCB-50Di board in the detector.
- B. Firmware initialization code version
This is the version of the initialization code written on the 50Di PCB board of the detector. The initialization code will be downloaded and the settings will be reset to the default (factory) settings by turning ON the power while pressing the initialization switch on the power box. Display “1.1.0” on the screen indicates version 1.01.00.
- C. Firmware normal code version
This is the version of the normal code installed on the 50Di PCB of the detector. Usually the system operates with this code. It must be updated as required. Display “1.1.00” on the screen indicates version 1.01.00.
