POLYDOROS SX 65/80

Troubleshooting Guide

Print No.: RX63-055.840.01.04.02
Replaces: RX63-055.840.01.03.02

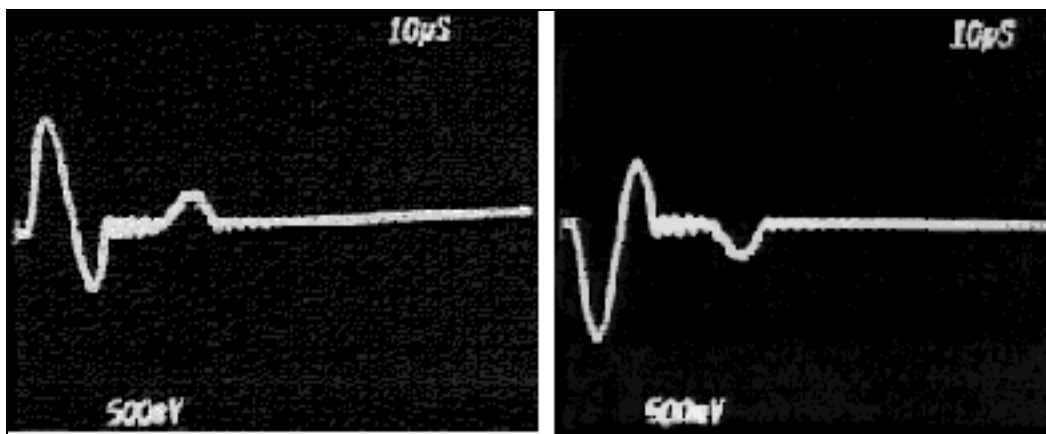
Fig. 1:

Pos. Signal (500 mV \triangleq 50A)

Neg. Signal (500 mV \triangleq 50A)

- The following requirements are to be checked in both oscillograms :
 - "Forward oscillation" : 120A \pm 10%
 - "Backward oscillation" : 50A \pm 10%
- On deviations in the amplitude:
- Generator OFF
- Connect oscilloscope to following points:
 - CH1: D100/X60 OUT_A
 - CH2: D100/X60 OUT_B
 - Trigger: D100/X64 SWR
- Switch on D100 OFF
- Generator ON
- Release FL or exposure.
- Compare pulses with diagram X2206/16, replace D100 in the case of deviation

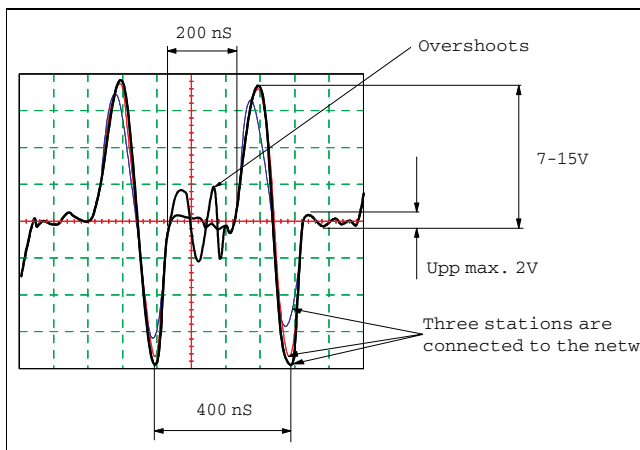
Disturbances occur during data transfer from what are called reflections (overshoots in the adjacent oscillogram). They occur, e.g. from cables that are not correctly terminated (closed). Explanation: A defined terminal resistance must be present at each last station in the net. Incorrect cables also lead to disturbances in data transfer, e.g. when Phase A and Phase B cables are switched in a connector. Poor connections and transitional resistances also cause disturbances in the XCS.

Fig. 4: Reflections in the XCS network

- Take one XCS component out of the XCS network and terminate it with a terminal resistor. Repeat the measurement of the XCS cable network; if an improvement is found, the XCS cable or the disconnected XCS component can be the cause.
- If disturbances cannot be corrected in the XCS cable network using Corrective Measure 1 or 2, replace the D320.
