sonicaid®

Service Notification

Subject: Introduction of New Waterproof Probe SP-726222 to replace SP-TDR-OP2HSB1 and SP-TDR-OP2HSB2

Products Affected: D920-P Serial No D920P0100000-xx onwards
FD1-P Serial No FD1X0100000-02 onwards
D920-LV All units

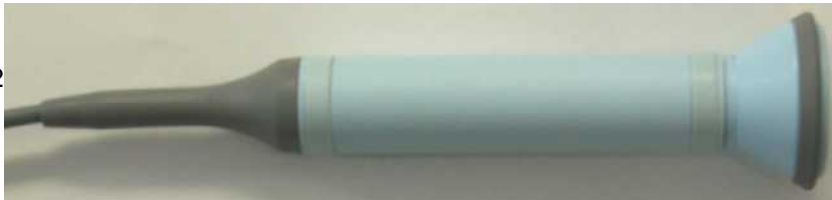
SP-TDR-OP2HSB2

The probes do look identical but on closer inspection the easiest method to tell them apart is the slot on the head assembly. *Please see below.*

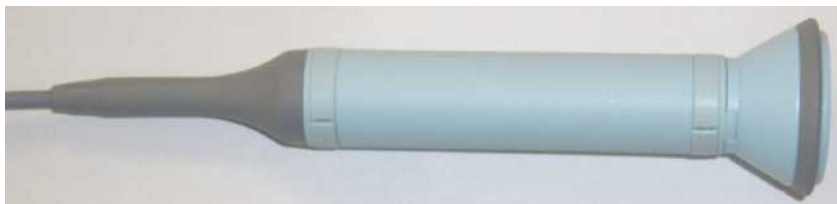
SP-726222

Slot in head **SP- 726219**

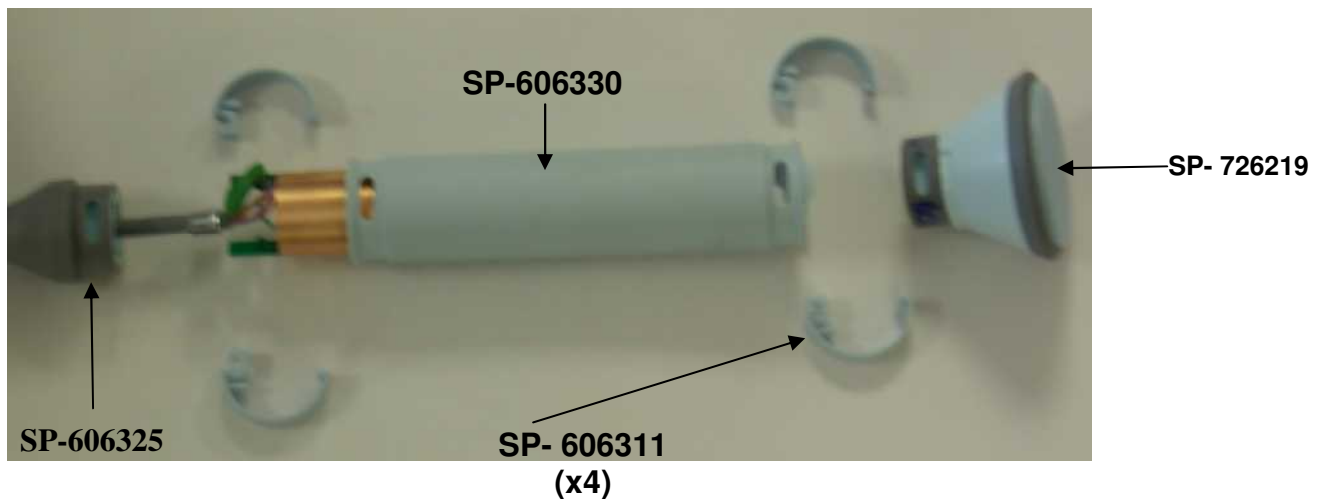
The Photograph below shows the parts which have changed, with the new part numbers. Parts with no numbers attached are the same as the previous aqua probe.

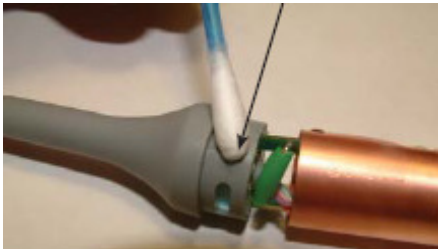
Slide Copper Screen over probe and position so that the internal fold is located against the edge of the PCB. Re-Solder in place using Tinned Copper Wires.

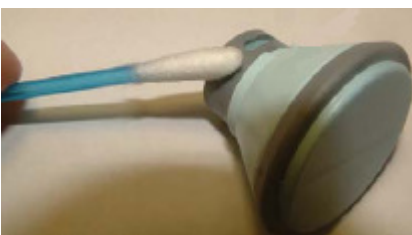
Slide Case Moulding over probe, ensuring that holes are fully aligned. Remove any excess silicone grease with a dry tissue.

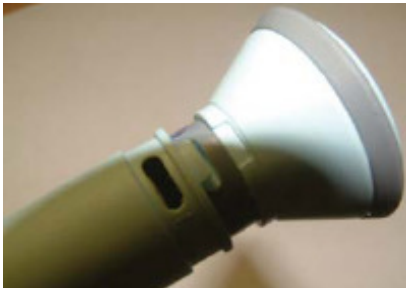
Apply Silicone grease to Head Assembly in areas as shown

Ensure that PCB fits into slot and that holes are aligned. Use the side of the head to press down.

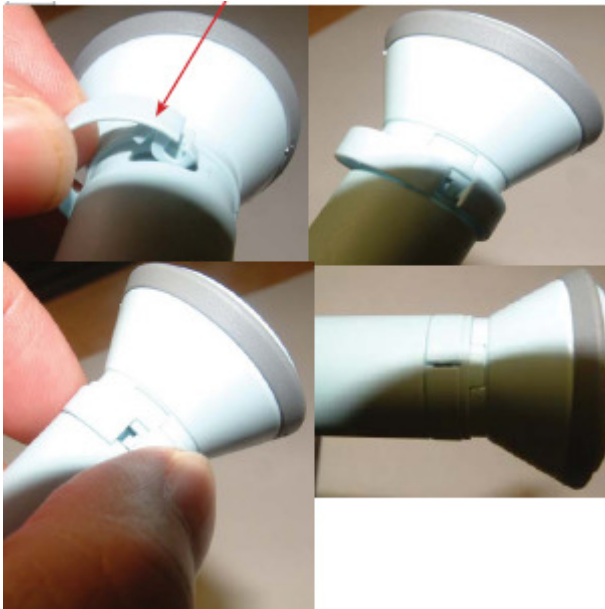
Ensure pins of PCB locate into head PCB socket.

Remove any excess grease from probe with a dry tissue. Check holes are fully aligned. Insert Case Clip as shown.
